Manhole Inspection Summary

Manhole # S55A__029MH

Insp Date: **6/24/08 10:18 AM**

Location Address: **rear 3641 pulaski hw**

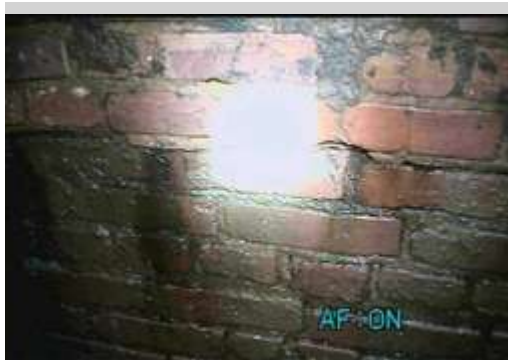
Defect 7

Infiltration: ☐ None ☐ Joint ☐ Cracks ☐ Mortar ☐ Roots ☒ **Wall**

infiltration in barrel wall

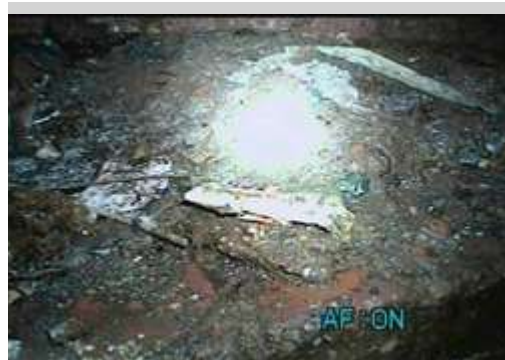
Defect 6

Condition: ☐ Sound ☐ Cracked ☐ Root Intrusion ☐ Deteriorated ☐ Leaks ☒ **Debris**

bench debris

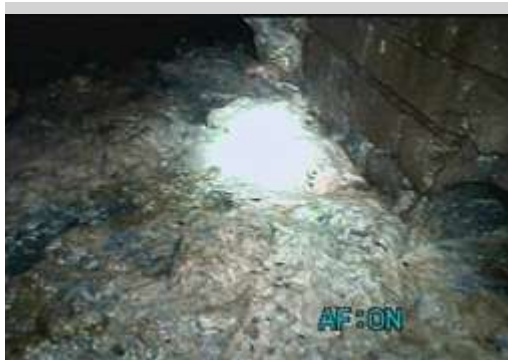
Defect 5

Condition: ☐ Sound ☐ Cracked ☐ Root Intrusion ☐ Deteriorated ☐ Leaks ☒ **Debris**

channel debris

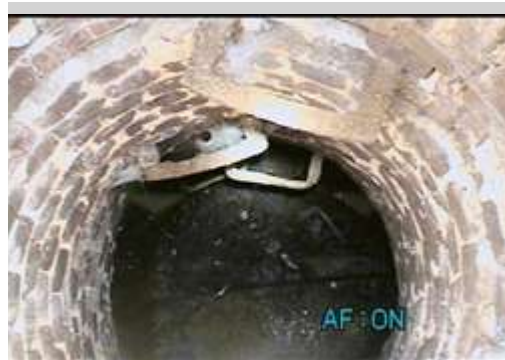
Defect 4

Count: **5** Missing: **0** ☒ **Corroded**

steps

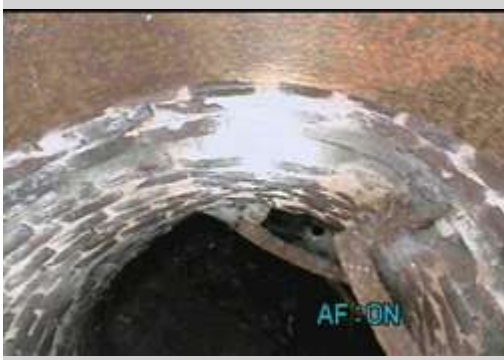
Defect 3

Comments **Corbel has shifted inward**

shifted corbel

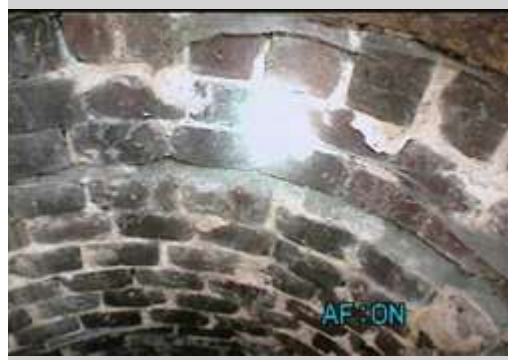
Defect 2

Condition: ☐ Sound ☒ **Cracked** ☐ Root Intrusion ☐ Loose Brick ☐ Deteriorated

corbel

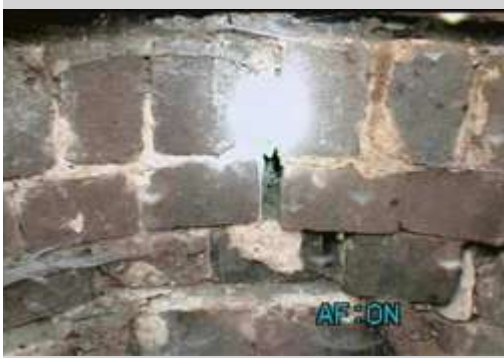
Defect 1

Condition: ☐ Sound ☒ **Cracked** ☐ Root Intrusion ☒ **Loose Brick** ☒ **Deteriorated**

cracked, loose bricks, deteriorated

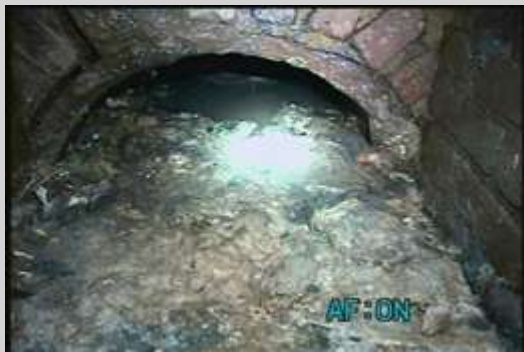
12 O'Clock Outflow

21 in. Circular Gravity Sewer
Pipe Out @ 12 O'Clock

Deposits: ☐ None ☐ Mud ☐ Sludge ☒ Debris ☐ Grease

Silt Depth: 6 (in.) Deposits Extent: Heavy

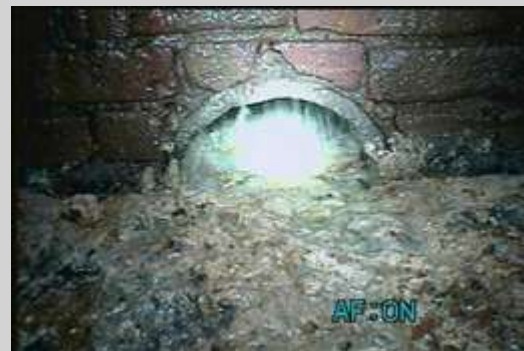
Drop In @ 3 O'Clock

Drop Condition: Clogged

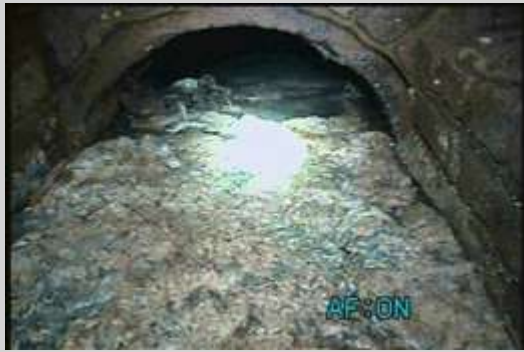
6 O'Clock Inflow

21 in. Circular Gravity Sewer
Pipe In @ 6 O'Clock

Deposits: ☐ None ☐ Mud ☐ Sludge ☒ **Debris** ☐ Grease

Silt Depth: **6** (in.) Deposits Extent: **Heavy**
